McGinnis Chen Associates Inc
ARCHITECTS | ENGINEERS

Re: 450 N Street Vision Glass 18th Floor Cracks – #12080.00 RP
Subj: Letter Report

This letter contains the investigation comments and findings for the reported vision glass crack May 01, 2012 at the Board of Equalization (BOE) Building (Project) located at 450 N Street in Sacramento, California.

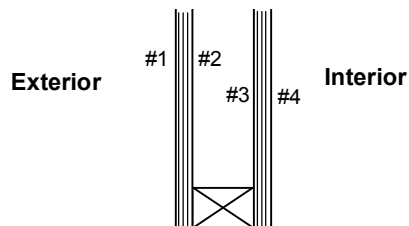
The vision glass is an assembled “Insulated Glass Unit” (IGU) comprised of an exterior and interior 1/4-inch thick piece of heat strengthened glass with a 1/2-inch aluminum spacer between (Figure 3). Each glass surface in an IGU is given a number for identification and reference. The following report will reference these glass surfaces.

Figure 3 – IGU with Glass Surfaces Identified
